ENGINEERING EXPERIMENT STATION BULLETINS

GUNITE AND CONCRETE ENCASEMENT TO INCREASE THE STRENGTH OF STRUCTURAL STEEL

BULLETIN No. 37

Professors of Civil Engineering
The Ohio State University

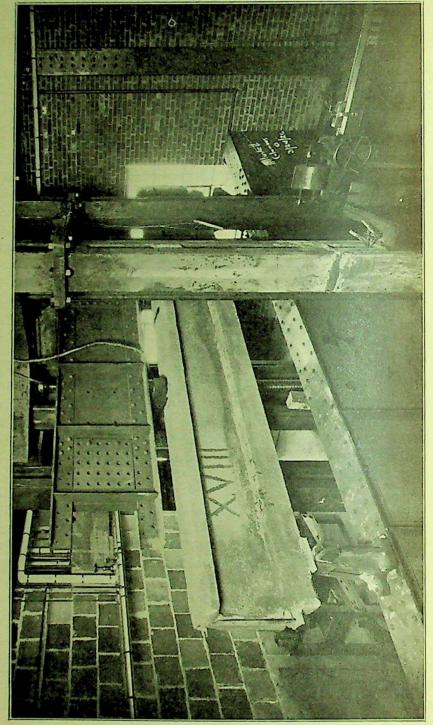
FIGURE 1. FRONTISPIECE, BEAM IN TESTING MACHINE

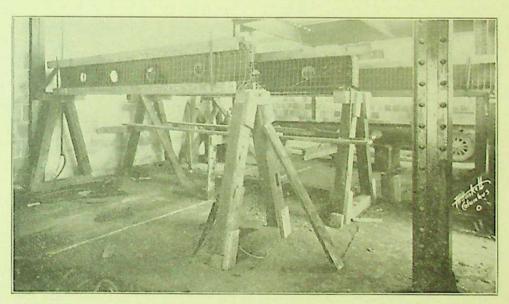
FIGURE 2. BEAMS READY FOR ENCASEMENT

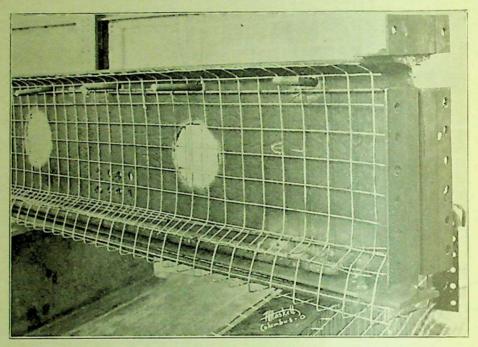
FIGURE 8

lost through the corrosion of the bottom flanges. The reinforcing steel was welded into the web or flange of the corroded members near the ends. Welding seemed to have no positive value, however, and was omitted in the High Street Viaduct tests. One stringer, Number XI, had the bars bent up as for shear reinforcement. Figure 7 shows the composite section of this member. Figure 8 is a photograph of beam Number XVII ready for encasement.

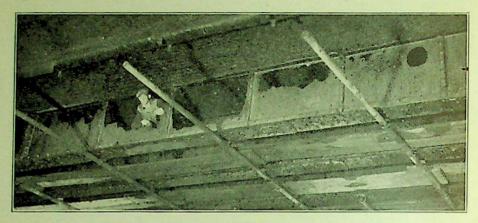
FIGURE 12

Shortly after the tests at the Engineering Experiment Station had demonstrated the possibility of strengthening corroded steel members, an opportunity for a practical test was presented at the North High Street Viaduct in Columbus, Ohio, where the badly corroded condition of the steel work made necessary either replacement or repair of the structure. As Figure 12 shows, holes in the

webs of some of the girders were large enough for a man to crawl through. It was suggested that encasement of the old girders in reinforced gunite might restore the carrying capacity of the viaduct, add a considerable period of years to its service, and at the same time save money and the inconvenience of detouring traffic during construction.

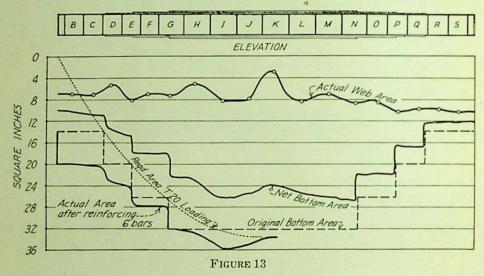
The two girders selected for the test, Numbers 14 and 15, were not the worst members in the structure, but were badly corroded.

The condition of Number 15 is shown in Figure 13. They were chosen because, on account of their location, they could be tested under load without seriously interfering with traffic. Motor trucks were placed in position as shown in Figure 14 over these girders,

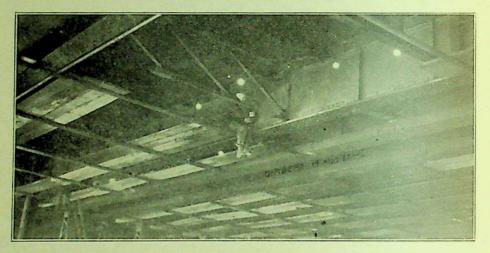
FIGURE 16

In addition to being restored to safe section and protected from further corrosion, these girders have been prepared for usefulness with the heavier traffic of the future by the design of the reinforcement for T-20, the heaviest loading specified by the Ohio Division

of Highways. The calculated stresses in the bottom flanges with this loading are 8740 lb. per square inch for dead load of corroded steel, 3835 lb. per square inch for dead load of reinforcement, and 5300 lb. live load, making a total of 17,875 lb. per square inch.

Figure 16 shows the appearance of the two test girders after encasement.

and deflection measurements and strain-gage readings of the deformation of the bottom flanges were taken. Caliper measurements were made of the steel sections, the girders were cleaned, reinforcing rods designed to bring the lower flange steel up to the necessary section were added, and the girders were encased in gunite applied by the Fritz-Rumer-Cooke Company, all without in any way interfering with traffic, either on the railways or on the street. After the encasement was 28 days old the girders were

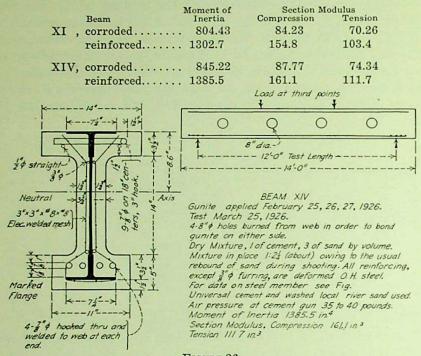
FIGURE 26

Stringers XIV and XI were reinforced corroded plate girders, both 28 days old at the time of testing. Reinforcing steel rods designed to give the member a value equal to that of a new beam of the same dimensions were placed near the bottom flange of each stringer. The bars of Beam XIV are shown in Figure 26. Figure

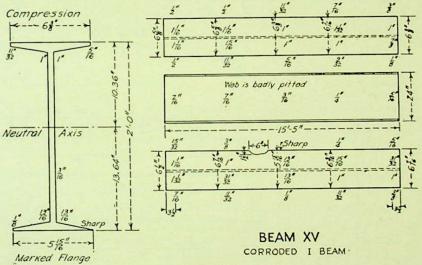
FIGURE 32

Figures 32, 33, 34, and 35 show the corroded condition of these I-beams. Caliper notes of the four beams are given in Table V, page 69.
